## Ocean Bay/Village, K-78

Kodiak Subarea Geographic Response Strategies

DRAFT October 30, 2008

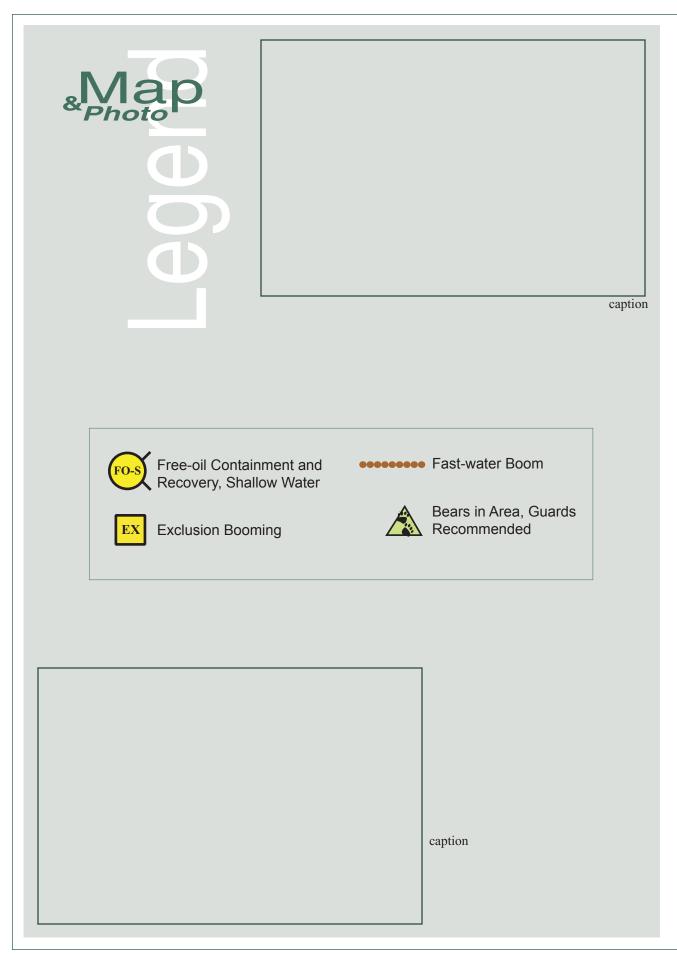
ID	Location and Description	Response Strategy	Implementation	Response Resources	Staging Area	Site Access	Resources Protected (months)	Special Considerations
K-78-01	Ocean Bay Nearshore waters in the general area of:  Lat. 57°27.53' N Lon. 152°28.31'W	Free-oil Recovery  Maximize free-oil recovery in the offshore & nearshore environment of Ocean Bay depending on spill location and trajectory.	Deploy free-oil recovery strike teams upwind and up current of Ocean Bay.  Use aerial surveillance to locate incoming slicks.	Deploy multiple free-oil recovery strike teams as required to maximize interception of oil before it impacts the sensitive areas in Ocean Bay.	Vessel Platform	Via marine waters Chart 16592-1	Same as K-78-02	Vessel master should have local knowledge.  Use extreme caution, shoal waters with numerous reefs and rocks.
K-78-02	Ocean Bay  a. Lat. 57°04.71'N Lon. 153°12.70'W  b. Lat. 57°04.66'N Lon. 153°12.82'W  c. Lat. 57°04.06'N Lon. 153°13.23'W  d. Lat. 57°03.73'N Lon. 153°13.21'W	Exclusion Exclude oil from entering the streams and intertidal area in Ocean Bay.	Access is possible via ATV trail from Port Hobron.  For each stream, place fast-water boom at an angle to exclude oil from entering.  All anchors can be deployed without vessel support.  Tend throughout the tide.  Boom Lengths:  a. 300 ft.  b. 200 ft.  c. 100 ft.  d. 100 ft.	Personnel/Shift  2 ea. vessel crew/general tech  Personnel/Shift  2 ea. vessel crew/general tech  Tending  Vessels  ATV w/ trailer  Personnel/Shift  2 ea. vessel crew/general tech  Tending  Vessels  ATV w/ trailer  Personnel/Shift  2 ea. vessel crew/general tech	Old Harbor Boat Harbor.	Via ATV Trail. Chart 16592-1	Fish- intertidal spawning- salmon (May-Sept.), herring(April-May)  Birds-waterfowl concentration, seabird nesting  Marine mammals- seals, otters  Habitat- marsh, sheltered rocky shoreline, gravel beaches  Human uses-commercial fishing, subsistence	Vessel master should have local knowledge. Site not surveyed. Tested: not yet
